Manhole Inspection Summary

Manhole # S25EE1A01MH

Location Address: **3970 EDGEHILL AVE**

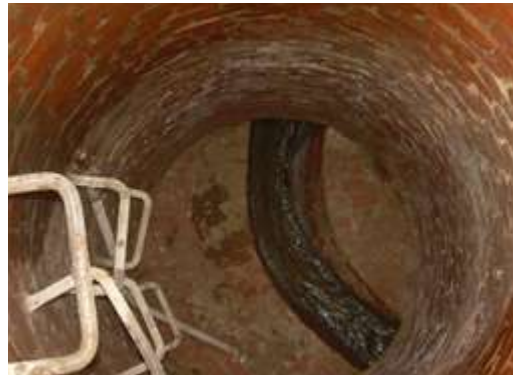
Top View

Corbel and Barrel infiltration. Evidence of surcharge - Bench debris.

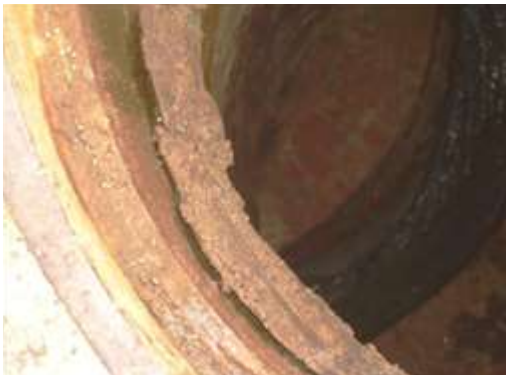
Defect

Frame leaks. Adjustment infiltration.

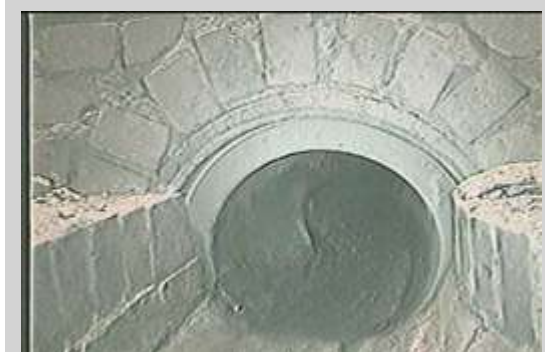
Pipe Out @ 12 O'Clock

Barrel deterioration and infiltration. Channel deterioration.

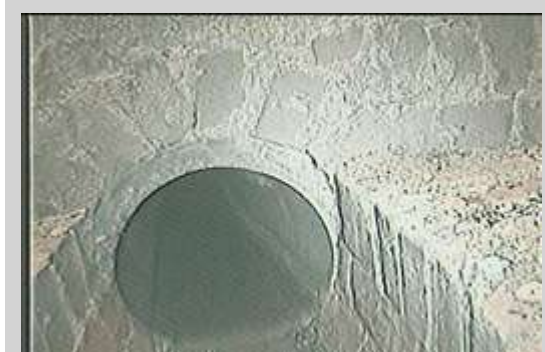
Pipe In @ 5 O'Clock

Infiltration: **Evidence** Pipe Seal Cond: **Cracked**
